Performance Based Risk Inspection (PBRI) Lifting Safety

April 18, 2018

PBRI Report

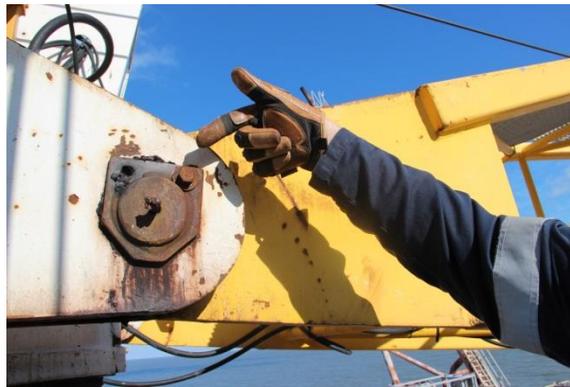
- d. **Facility was issued an I-105 PINC.** At the time of the BSEE Inspection, the following was found on A Platform: crane a bolt was missing from the boom heel section. Repaired at time of the inspection; **Facility was issued an I-141 PINC.** At the time of the BSEE Inspection the following was found on A Platform: Lack of grease, load sensor had no oil, missing and cracked glass, diesel hose cracked. D Platform: cracked and missing glass, missing door, back glass has paint over spray. G Platform: missing and broken glass; **Facility was issued an I-147 PINC.** At the time of the BSEE Inspection the following was found on G Platform: crane on the main hoist line needed to be re-spooled.

Bolt was missing from the boom heel section on platform crane

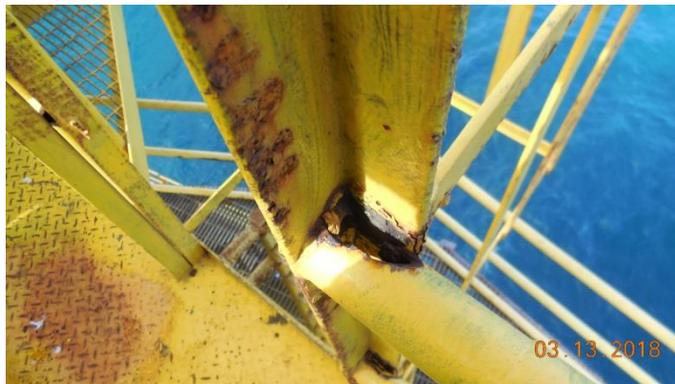
Handrails near the top of the crane access ladder corroded

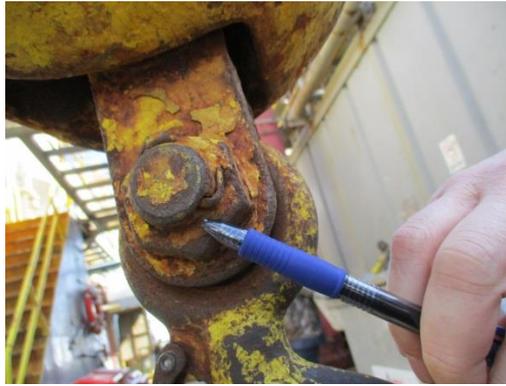
- e. USCG shut in both of the jack-up rig's gantry cranes (approved for personnel lifting) On both cranes, the winches were recently replaced and the vessel failed to provide required records proving load test prior to use. Other issues were failed cotter retaining pins on the auxiliary line overhaul balls of both gantry cranes, bird-caged/crushed wire rope at wedge socket on one gantry crane, and worn hydraulic and fuel lines. Additionally, several probable electrical and watertight integrity issues were identified warranting follow up.

Failed cotter retaining pins on the auxiliary line overhaul balls of both gantry cranes

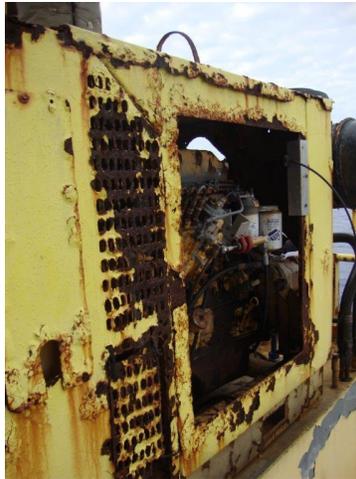
- o. There was severe corrosion on the engine covering. At the time of the inspection, it was not an immediate safety hazard, but it needs to be addressed in the near future. This corrosion was noted on the previous three crane inspections. There are missing pages in the annual and quarterly inspections. Both lack page two of the reports.

Severe corrosion on the engine covering

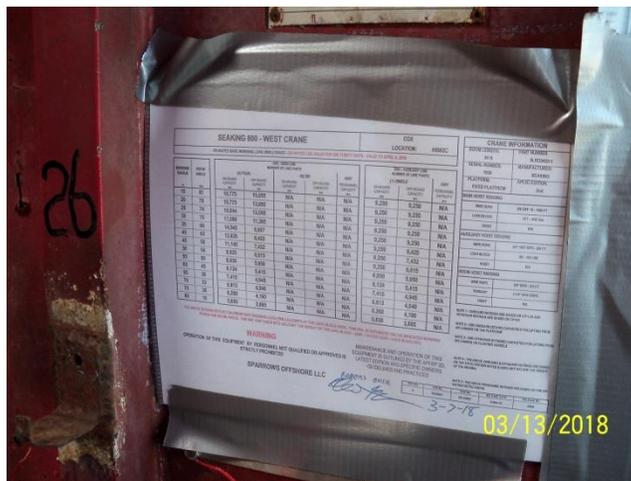
- e. The crane was recently de-rated for boom hoist material loss. Current load chart showing de-rating indicates no personnel capacity. Annual inspection report notes that neither the auxiliary line

Load chart showing de-rating of crane 6 days prior to inspection

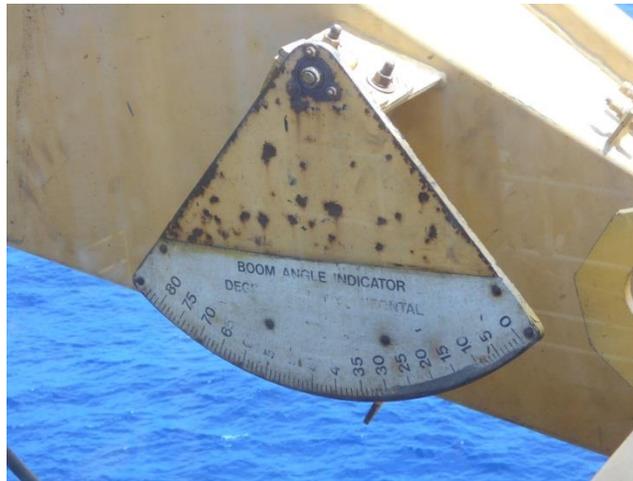
- m. Annual inspection report notes that the front crash bar keeper roll bar on West Crane is broken on one side and needs to be welded back into place. Load chart in crane did not show correct wire rope size on main hoist. Numbers are faded on angle indicator.

Numbers are faded on angle indicator

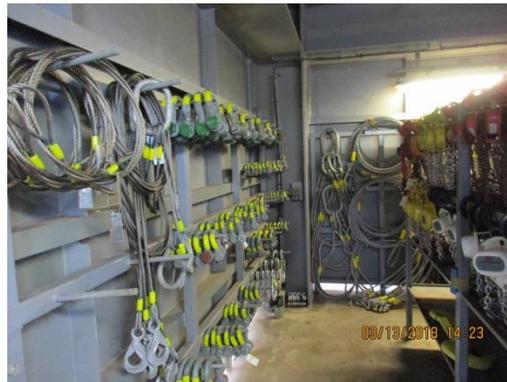
Commendable, "meticulously maintained" equipment maintenance

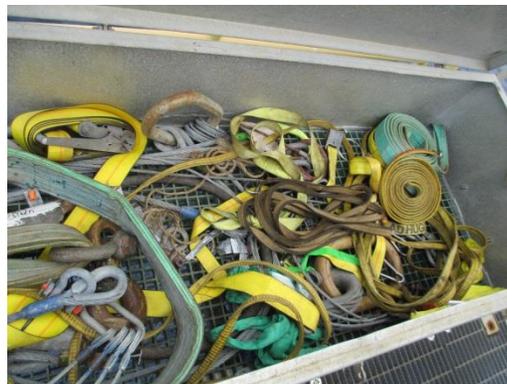
- d. Lifting equipment is marked with a rated limit and the manufacturer, but the serial number and the inspection date were not predominantly visible. Lifting equipment storage was not organized well, and it had abrasive wires contacting nylon straps.

Abrasive wires contacting nylon straps in storage container

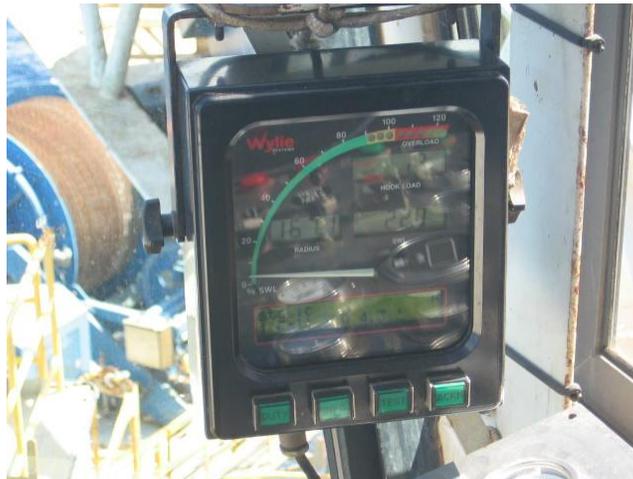
Crane Load Indicator with unknown calibration

About 20 percent of the facilities inspected during the PBRI had no load-indicating system in place, or had no available record(s) of calibration. Recommendation: Although load indicators shall not be used to test cranes, the readings should be recorded on each lift where load indicators are installed on the crane. Additionally, if load indicators are present, Operators should have calibration procedures in place.

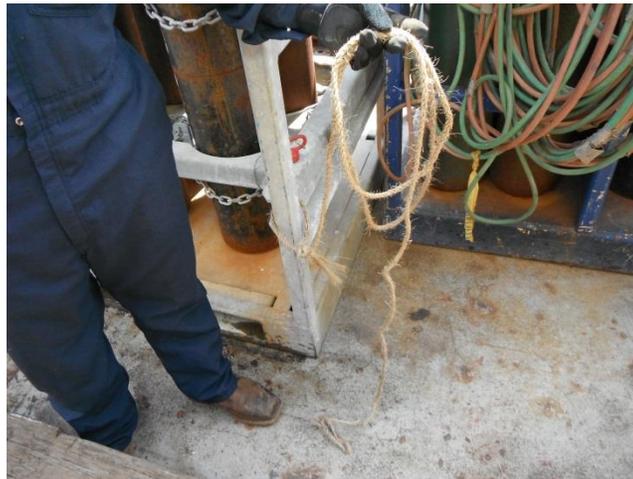
Tag line in use at subject facility

The inspections suggest that operators Safe Work Practices (SWP) with tag lines are not implemented, specific to line length/strength requirements, or personnel are not familiar with those that exist. Recommendation: All lifts on the OCS should be evaluated for all risks, and the appropriate tag lines and use of tag lines should be reviewed. This includes defined length, strength, and diameter.

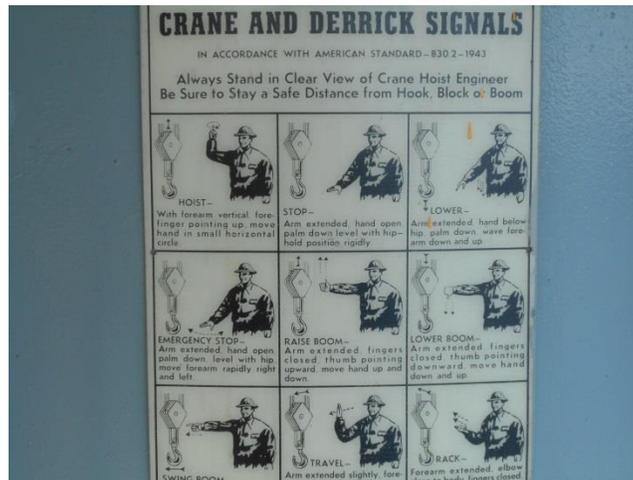
- e. Emergency Stop signal posted on crane differs from current API requirements.
- f. There is some room for improvement in hand signal knowledge/consistency. When interviewing the crane operators separately, they had different signals for all stop/emergency signaling.

Outdated Placard on crane

BSEE identified multiple facilities which lacked evidence to support personnel were knowledgeable of proper lifting signals as referenced in API RP 2D. Recommendation: Operators shall review the "Standard Hand Signals for Controlling Crane Operations" figure in API RP 2D, and verify those signals are implemented and understood by all lifting personnel on their facilities.
